Manhole Inspection Summary

Manhole # S25CC_056MH

Location Address: **1106 RIGGS AVE**

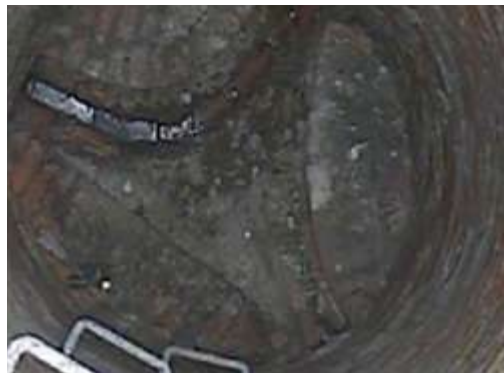
Top View

lid does not sit well within the manhole frame

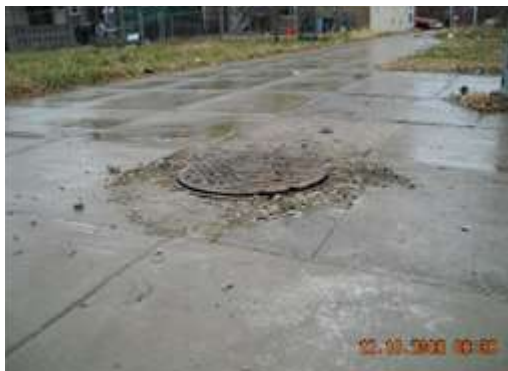
AFTER CONCRETE WAS REMOVED,
MANHOLE LID SITS ABOVE THE RIM.

INFLOW DUE TO SHEETING

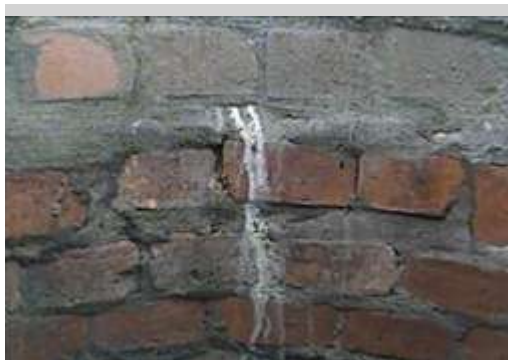
Defect 1

☒ **Leaks**

INFILTRATION DUE TO FRAME LEAKS

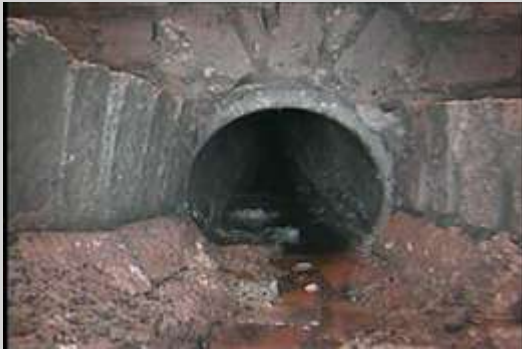
12 O'Clock Outflow

10 in. Circular Gravity Sewer
Pipe Out @ 12 O'Clock

Pipe Height: **9.6** (in.) Rod and Bar (Angled)
Pipe Material: **Clay** ☐ Pipe Lined
Invert Depth: **10.12** (ft.) Flow Characteristics: **None**
Deposits: ☒ None ☐ Mud ☐ Sludge ☐ Debris ☐ Grease
Silt Depth: (in.) Deposits Extent:
Infiltration: **None** Pipe Seal Cond: **Sound**

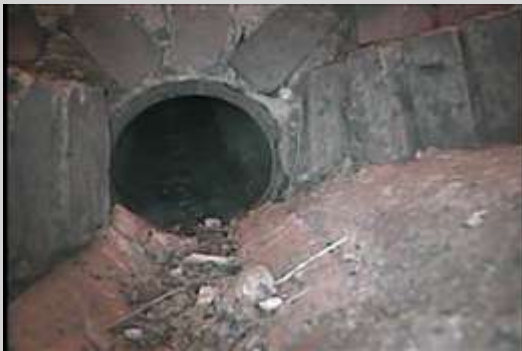
4 O'Clock Inflow

8 in. Circular Gravity Sewer
Pipe In @ 4 O'Clock

Pipe Height: **8.4** (in.) Rod and Bar (Angled)
Pipe Material: **Clay** ☐ Pipe Lined
Invert Depth: **9.97** (ft.) Flow Characteristics: **Turbulent**
Deposits: ☐ None ☐ Mud ☐ Sludge ☒ **Debris** ☐ Grease
Silt Depth: **2** (in.) Deposits Extent: **Light**
Infiltration: **None** Pipe Seal Cond: **Sound**

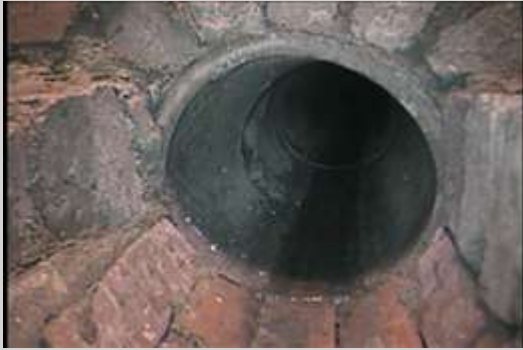
9 O'Clock Inflow

10 in. Circular Gravity Sewer
Pipe In @ 9 O'Clock
